# Dormington and Mordiford Group Parish Council

| RISK ASSESSMENT | | Allotment, Shepherds Orchard, Mordiford HR1 4FD | | | | | |

## Walk Around Risk Assessment observations carried out on the 19<sup>th</sup> May 2025

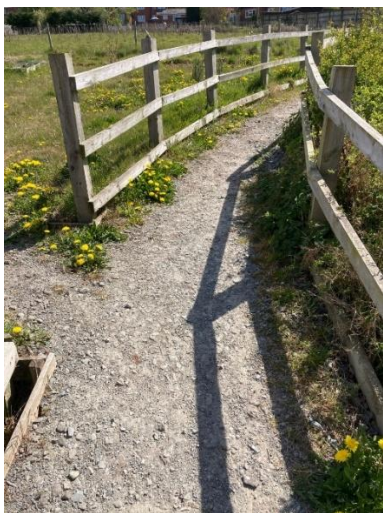
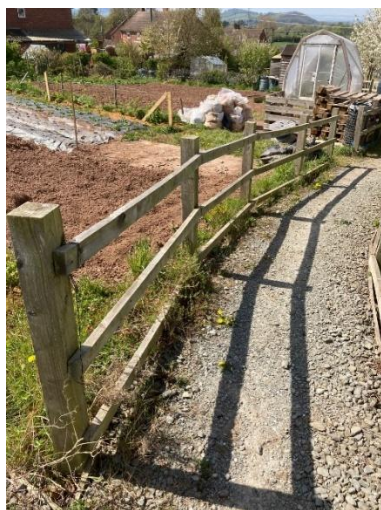
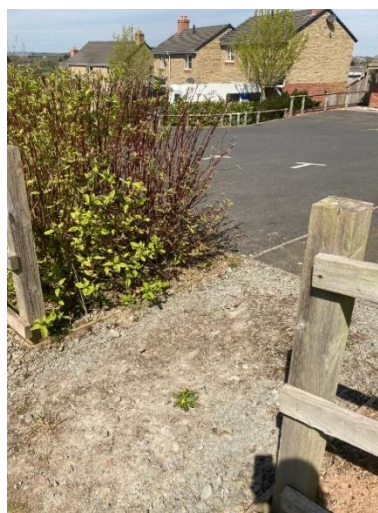
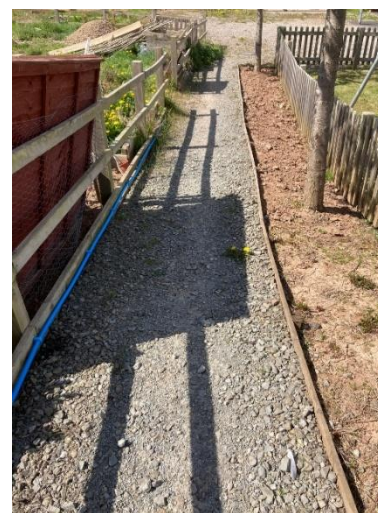
Pathways on the Allotment (original photos)

| RISK ASSESSMENT | | Allotment, Shepherds Orchard, Mordiford HR1 4FD | | | | | |
|---|---|---|---|---|---|---|---|
| Pathways made of rough stone with protruding edging and raised drain cover | <ul style="list-style-type: none"><li>• Tripping hazard</li></ul> | <ul style="list-style-type: none"><li>• Allotment holders</li><li>• Local residents</li><li>• Contractors</li><li>• Employees</li><li>• Councillors</li></ul> | <ul style="list-style-type: none"><li>• Visual inspection to ensure the surfaces do not become too uneven</li><li>• Visual inspection to ensure gravel level is at a height that mitigates edging trip hazard</li></ul> | 2 | 3 | 6 | Clerk to find out who is responsible for the pathways – Citizen or PC? |

- Who pays for the water?
- The edging surrounding the path is protruding because the gravel level has dropped. This is now a trip hazard. – Citizen's responsibility or PC?

- There is a raised drain on the path from the carpark to the allotment. This is also a trip hazard and again wouldn't be if the gravel level was higher.

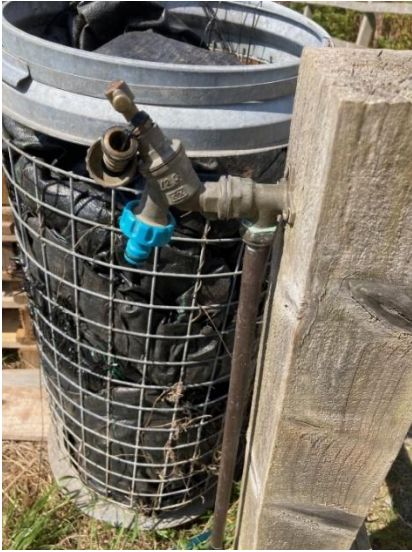
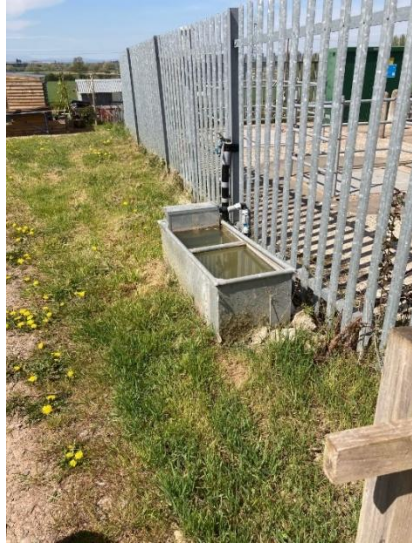
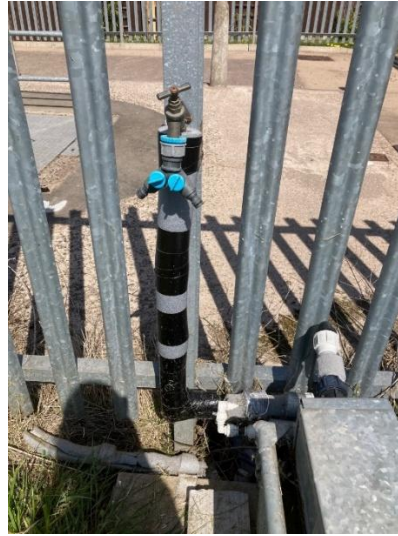
Waterpoints x 2 (original photos)

| Tap water points (x2) – minimal hazards. | <ul style="list-style-type: none"> <li>Stagnant water in trough</li> </ul> | <ul style="list-style-type: none"> <li>Allotment holders</li> <li>Local residents</li> <li>Contractors</li> <li>Employee</li> <li>Councillors</li> </ul> | <ul style="list-style-type: none"> <li>Taps are maintained in good order, and water is turned off between October and April to reduce pipe damage.</li> <li>Water should be changed regularly through use</li> </ul> | 1 | 1 | 1 | Tenants |

- Stagnant water in trough next to bottom tank. Is it used?
- The fence needs repair at the top end where the wood as split, broken off in places or has splinters sticking out – needs repairing/replacing – PC?

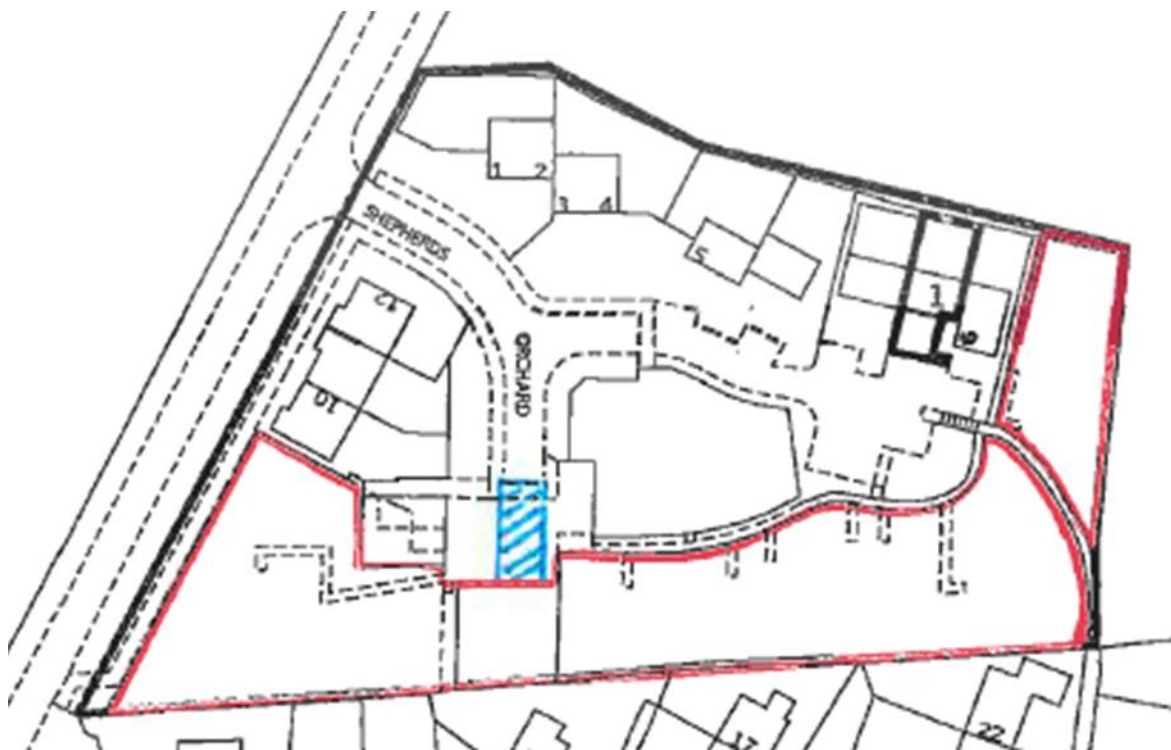
The site is split into 14 plots of mixed size, a small area to be used by all tenants (a community plot), and a community orchard with 9 fruit trees. The site is outlined in red below.
